Request for Proposal

**Terrace Repair at
1300 Paris Street**

Subject: PHSD Condition Assessment, 1300 Paris Street, Sudbury, ON

STRUCTURAL CONDITION ASSESSMENT

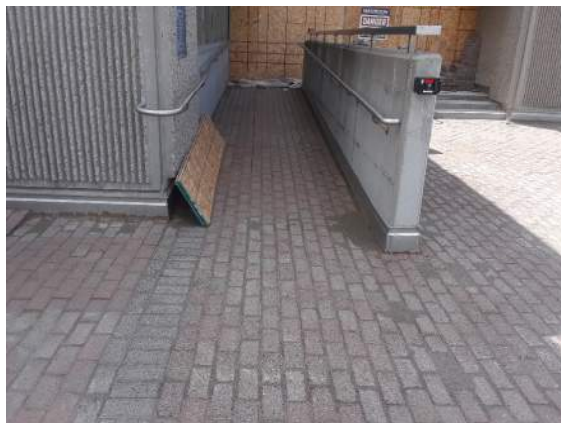
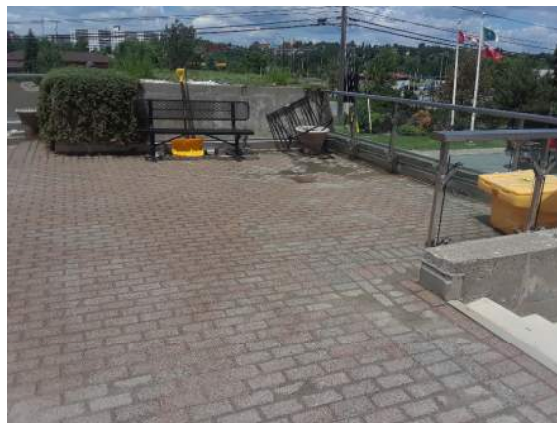
- 1.1 The site was visited on June 10, 2022, to review the condition of the existing Podium structure and interior Corridor and Lab areas.
- 1.2 The existing Podium waterproofing is leaking, water flow is evident within the interior of the building and is being caught by drip catchers installed by the building operator and on the floor on the lower level of the building.

- blockages below the concrete pavers. These drains need to be exposed, cleaned and where required replaced to permit positive drainage of the podium.
- 1.4 It was also noted that the existing caulking between the existing exterior precast panels are showing signs of cracking. As this is the only defense against water penetration into the building, it is recommended that these caulked joints be reviewed thoroughly and where cracked and deteriorated, removed and replaced at all locations around the building.
 - 1.5 There is cracking in the concrete at the existing stair at the existing corner near the ramp.

- 1.6 Existing fireproofing on existing steel beams needs to be reinstated.
- 1.7 Very limited rusting of existing steel is evident. The existing leaking is localized to steel immediate adjacent to concrete wall and podium. Refer also to structural comments.
- 1.8 There are holes in the existing masonry wall at the corridor in numerous locations. These openings need to be properly closed, sealed and fire-stopped.
- 1.9 The existing podium roof drain in the Storage areas are showing signs of leaking on the interior, these drain lines are not insulated and condensation is evident.
- 1.10 There are water marks and efflorescence on the existing concrete wall in the Storage areas
- 1.11 The building maintenance contractor has installed a temporary drip catchment system to divert any water leaking into the Lab space at the ceiling.

- 1.12 There is no immediate threat to the life safety of the occupants of this building; however, the existing waterproofing membrane, insulation, flashing details, wear layers of the existing podium need to be addressed immediately. Immediate removal and replacement of existing system is recommended.

- 1.13 The podium is poorly insulated with between 1"-2" of rigid insulation (R5-10) only located above the podium. It is recommended that additional insulation be added to comply with the minimum insulation values as defined by the Ontario Building Code.

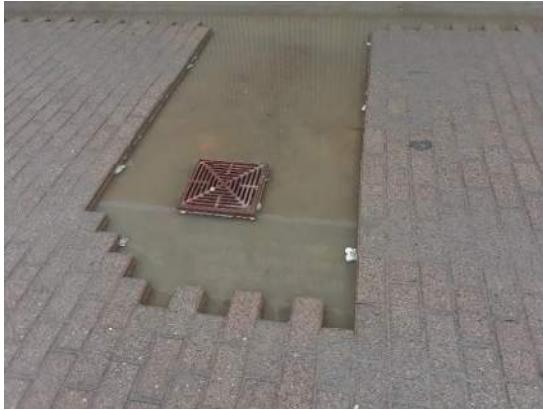
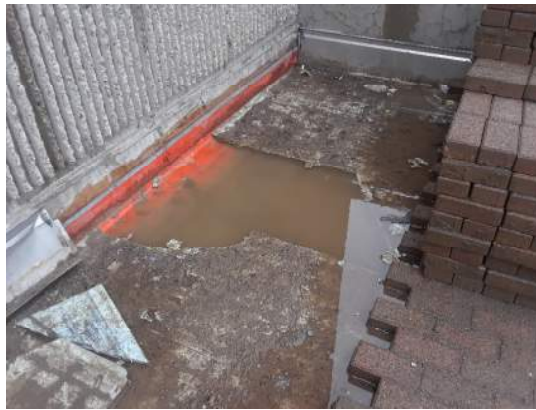
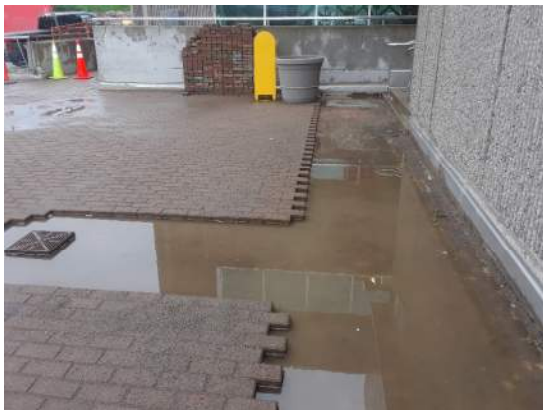
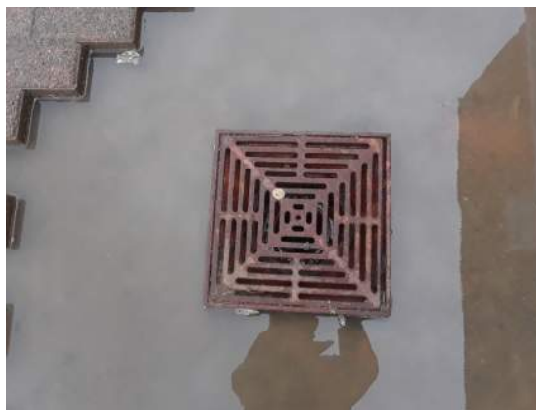
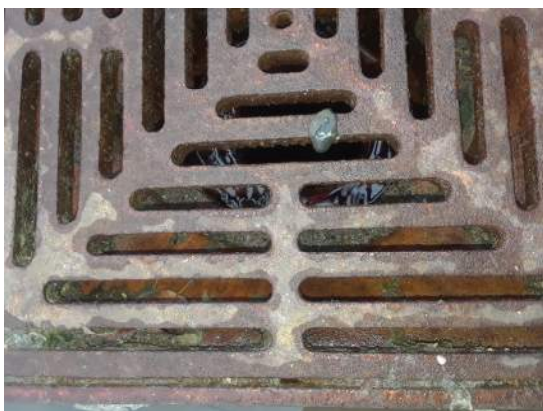
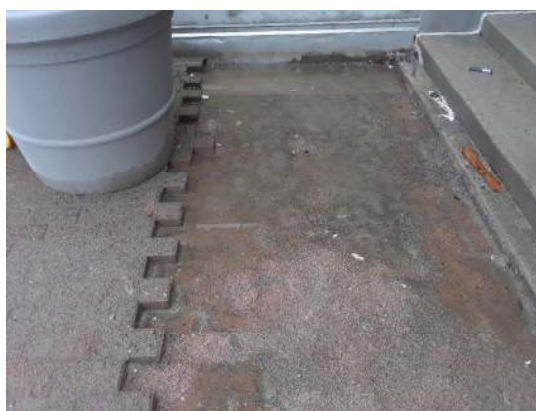
- 2.5 Contractor was contacted to clean around all the roof drain baskets to ensure proper drainage of water into the roof drains.

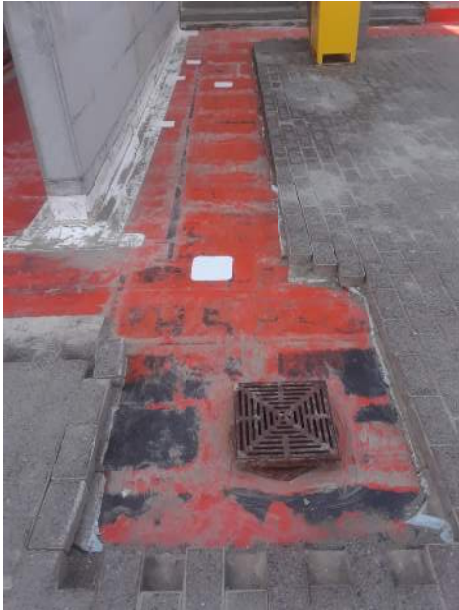
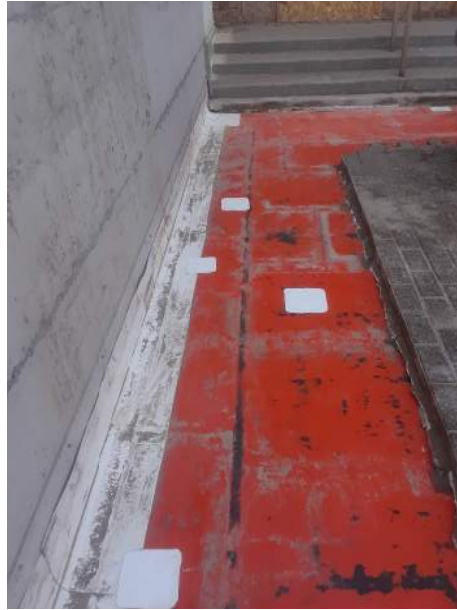
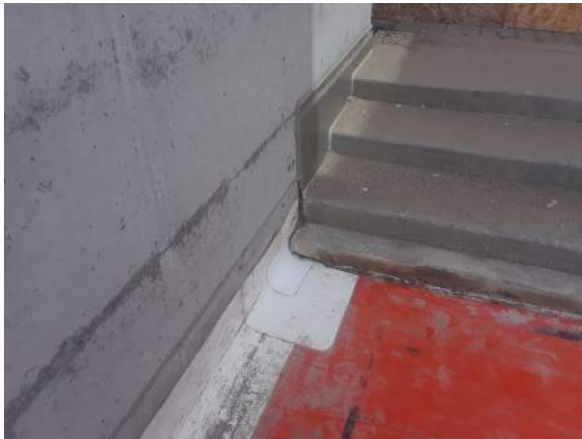
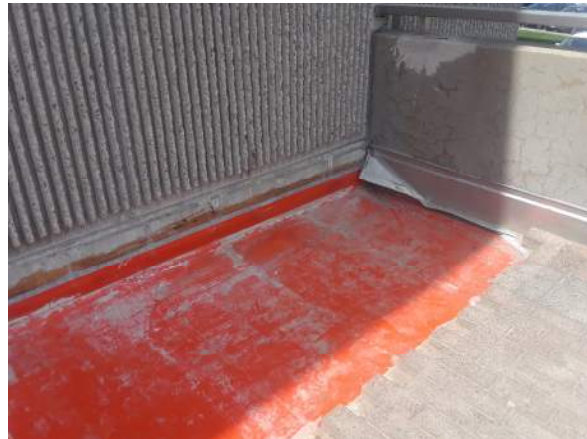
- 3.5 Contractor indicated that the roof drain near the bottom of the ramp is rusted closed and could not be removed, they were able to clean out the basket which allows the water to flow into the roof drain.

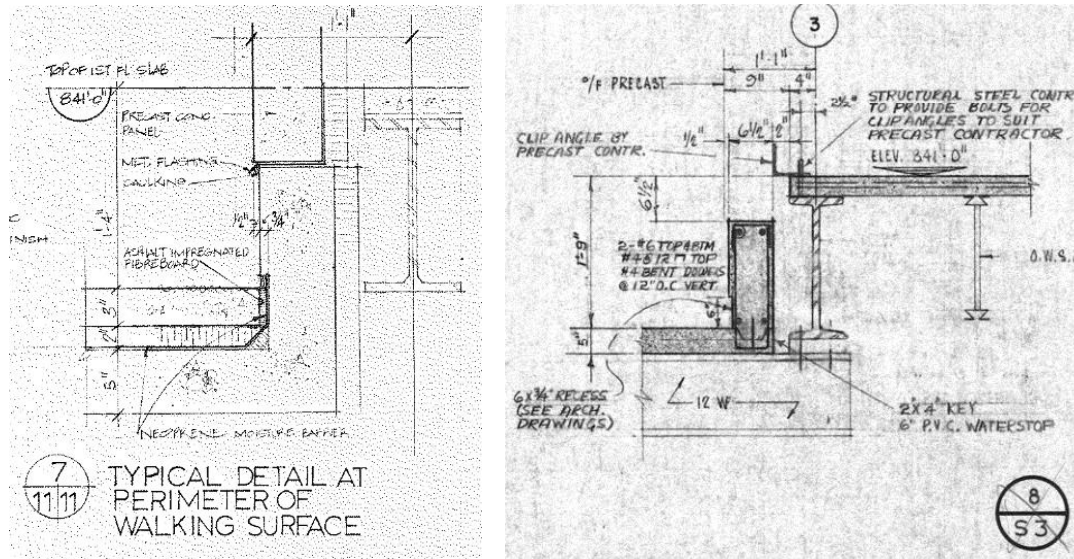
Figure 1: Original architectural and structural curb details.

The curbs and waterproofing membrane make it unlikely that leakage would occur through the Podium level at these locations, in our opinion. We anticipate that leakage identified at these locations is due to the presence of water in the cavity behind the precast cladding above. Precast wall panels rely on sealant joints between adjacent panels, low permeability concrete, and flashing to prevent water ingress. Regular maintenance (i.e., sealant replacement, flashing replacement and application of concrete surface sealers) is required to ensure that the wall assembly continues to perform over the life of the building. A detailed review of the precast cladding is recommended with the expectation that a general maintenance program will have to be developed and implemented to mitigate water ingress through the building envelope.

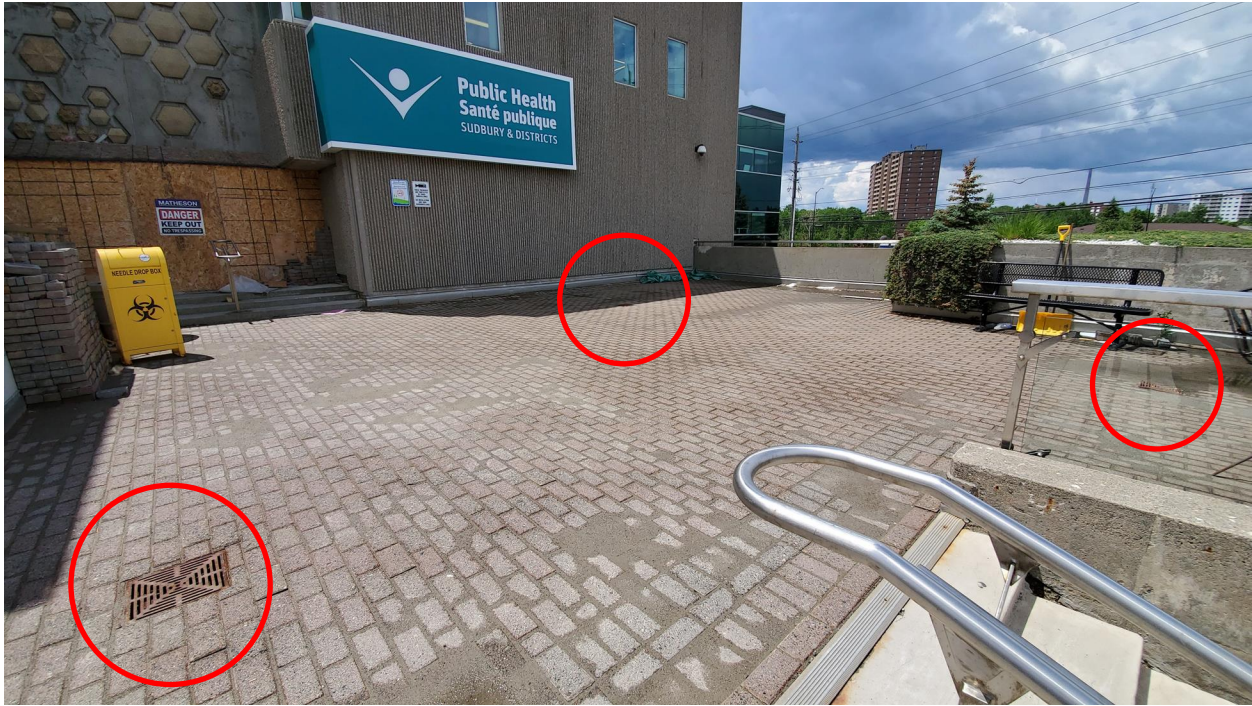
Figure 1: Podium surface looking southwest. Drain locations noted.

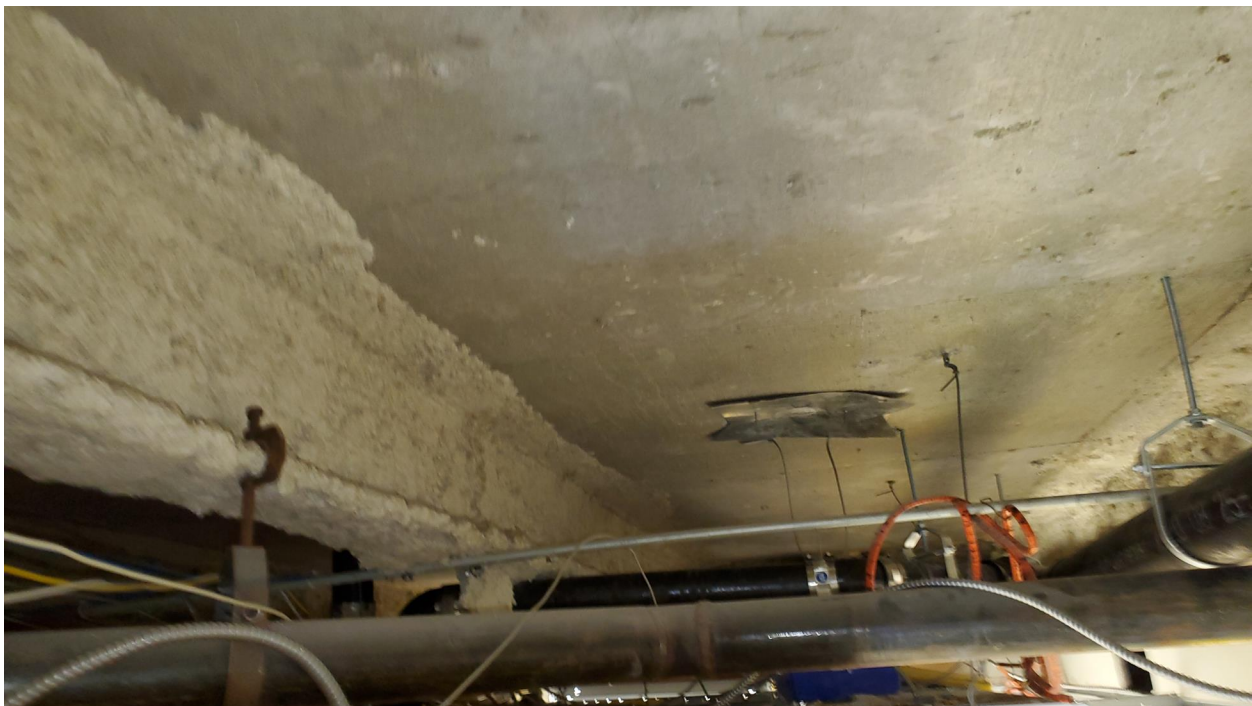
Figure 2: Typical Podium framing.

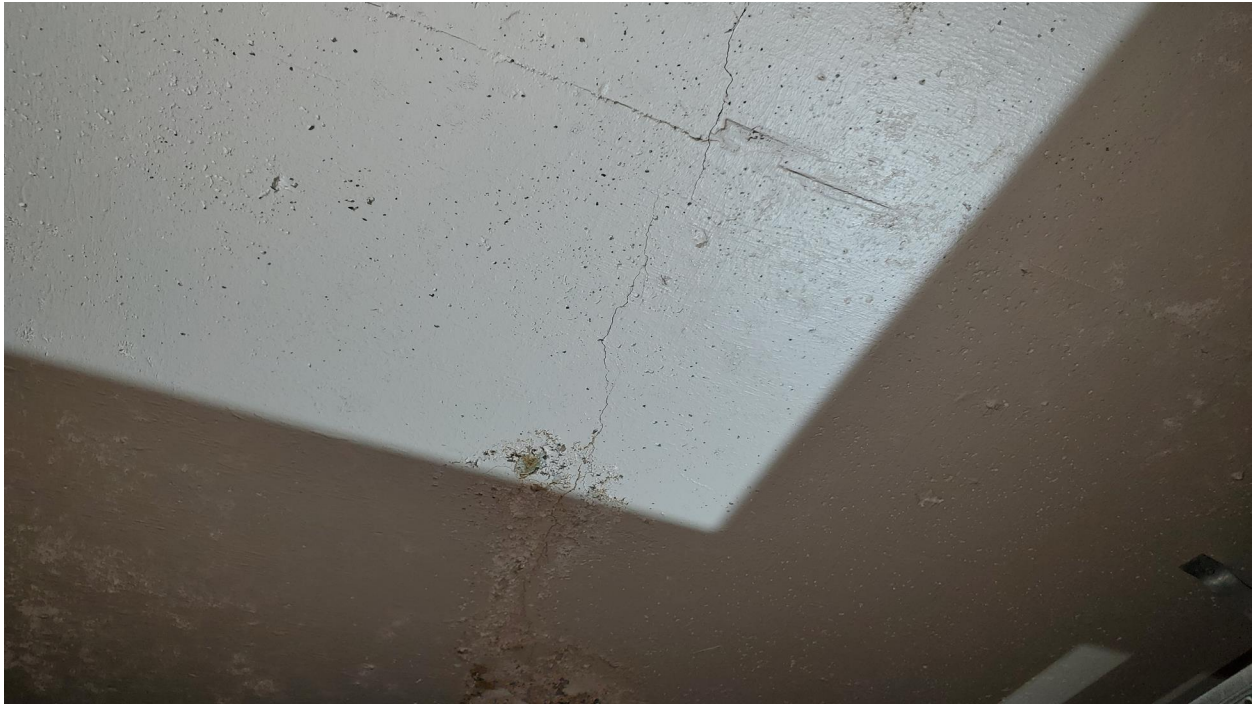
Figure 3: Typical shrinkage crack at underside of slab without any evidence of water infiltration.

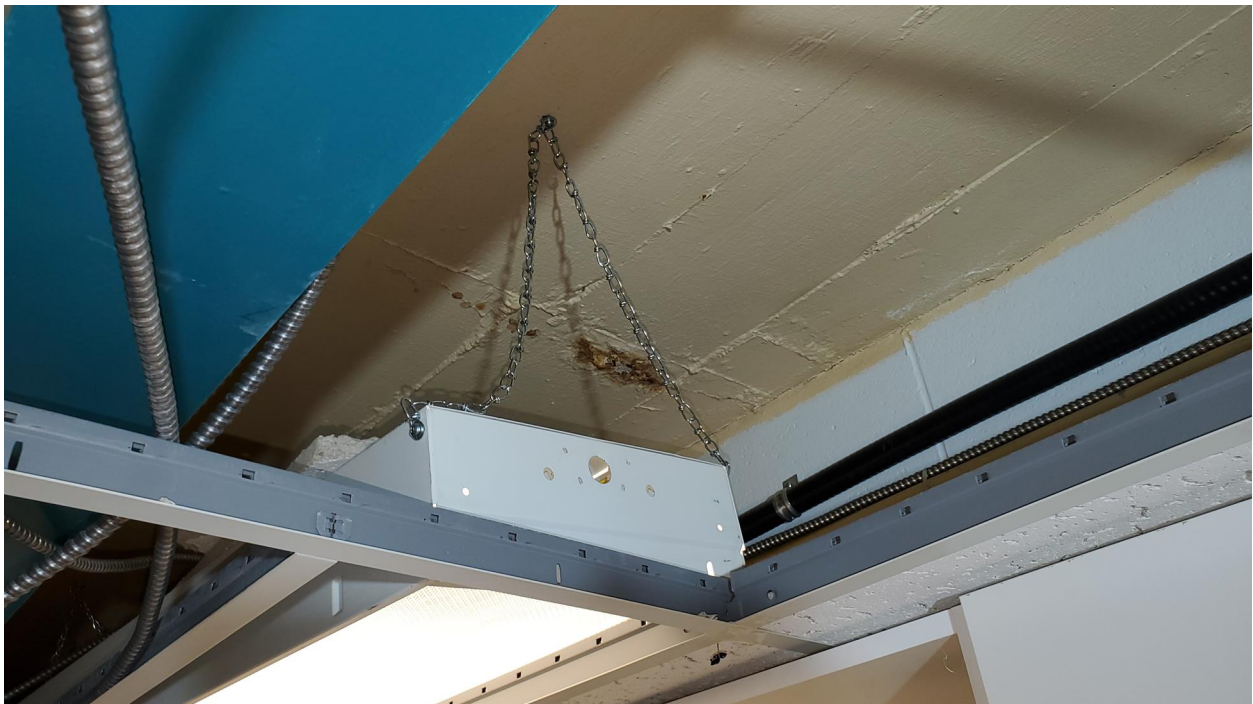
Figure 4: Underside of Podium slab exhibiting evidence of minor water infiltration through a crack.

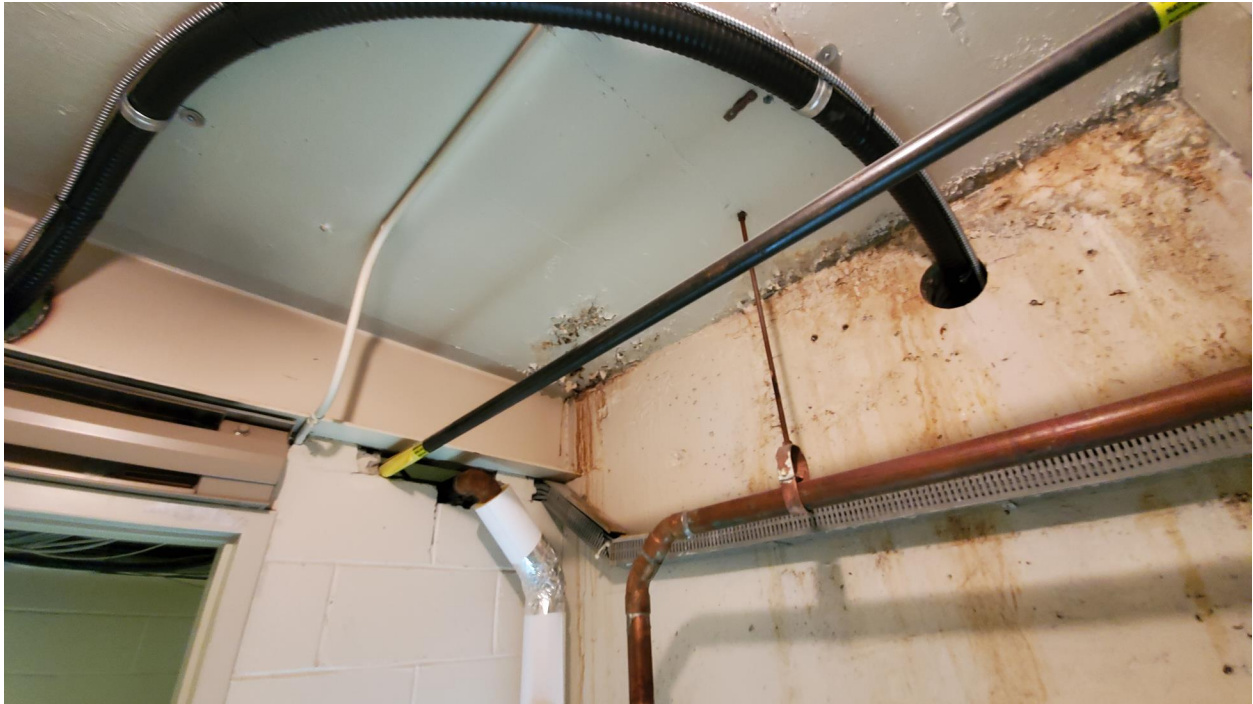
Figure 5: Underside of Podium slab exhibiting evidence of excessive water infiltration through a crack and at the cold-joint between the slab and basement wall.

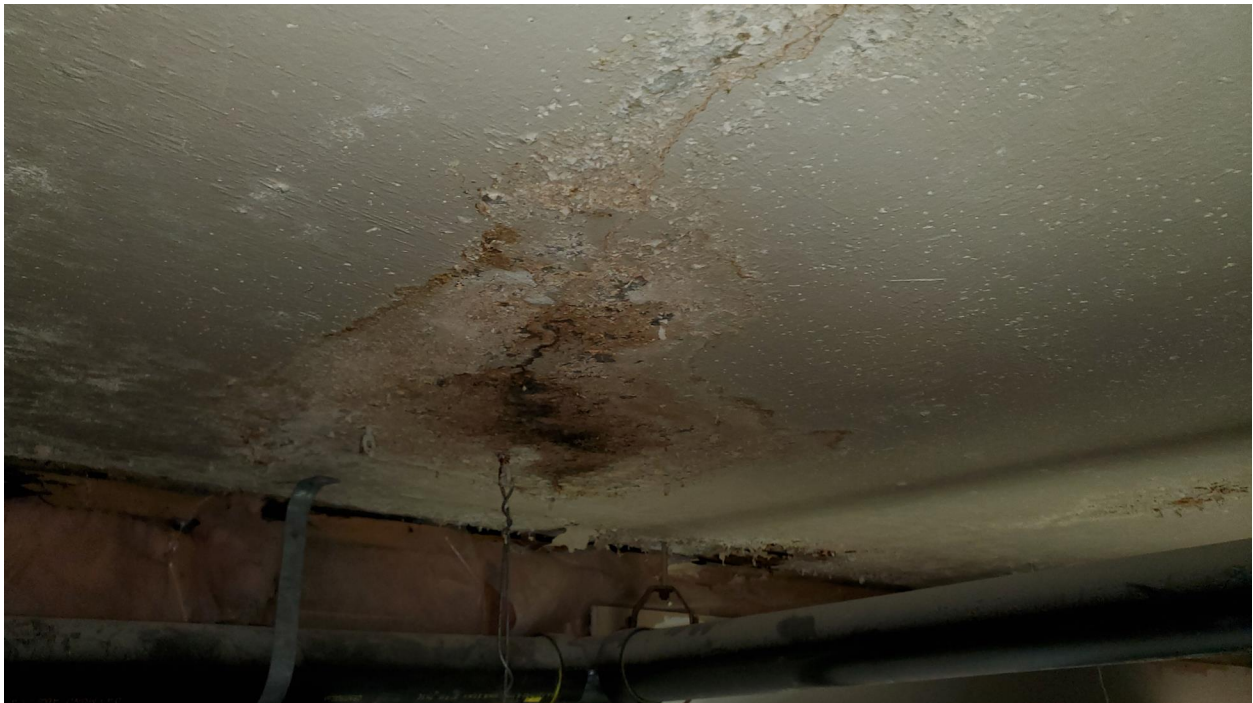
Figure 6: Underside of Podium slab exhibiting evidence of excessive water infiltration through a crack.

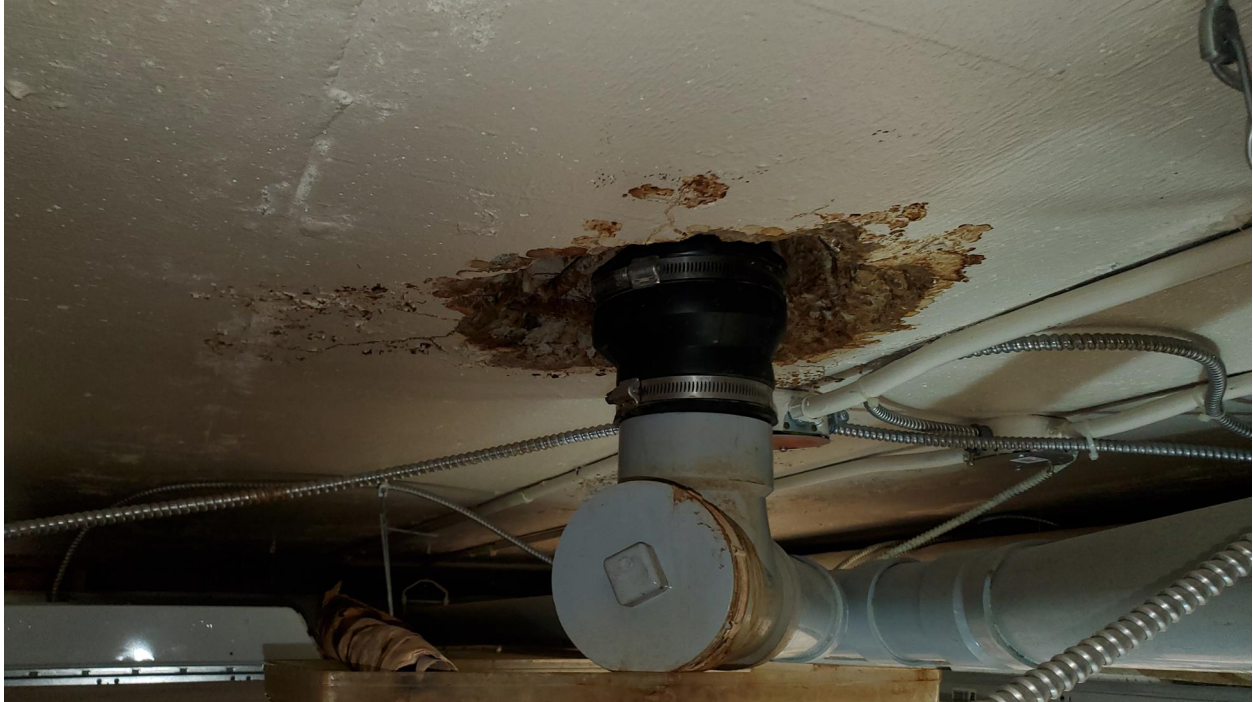
Figure 7: Underside of Podium slab exhibiting evidence of excessive water infiltration at a drain.

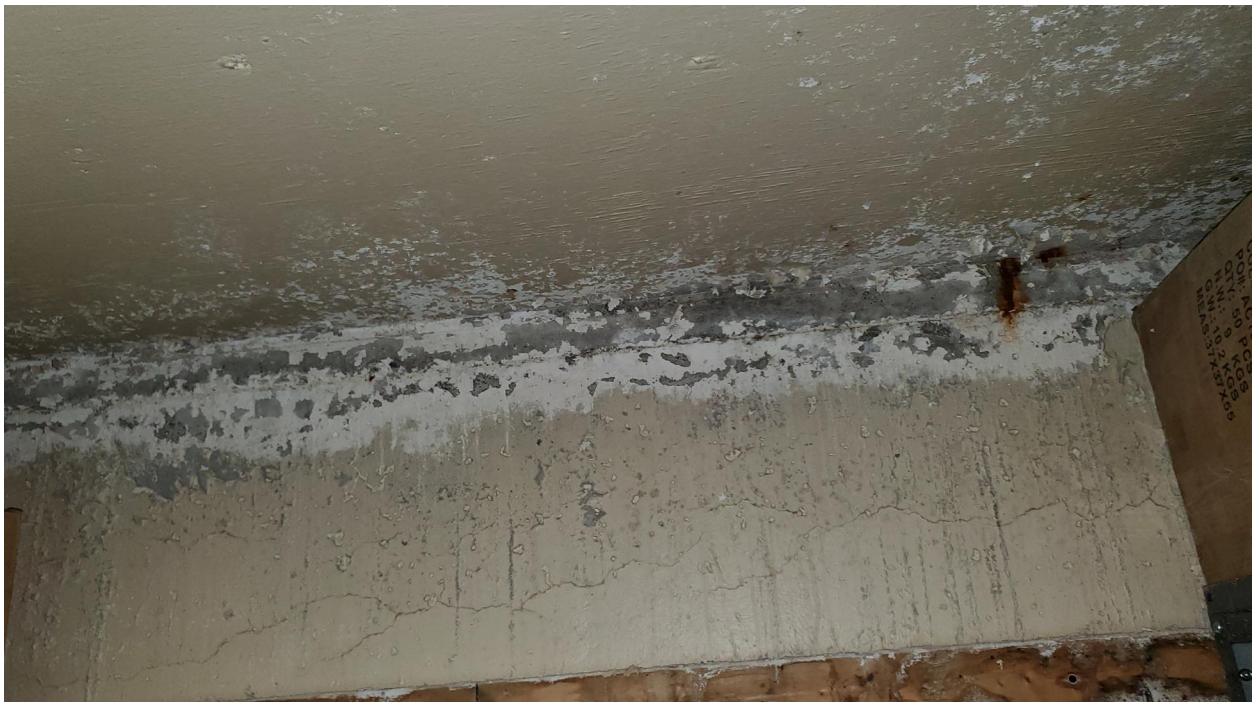
Figure 8: Cold-joint between the concrete slab and basement wall exhibiting evidence of excessive water infiltration.

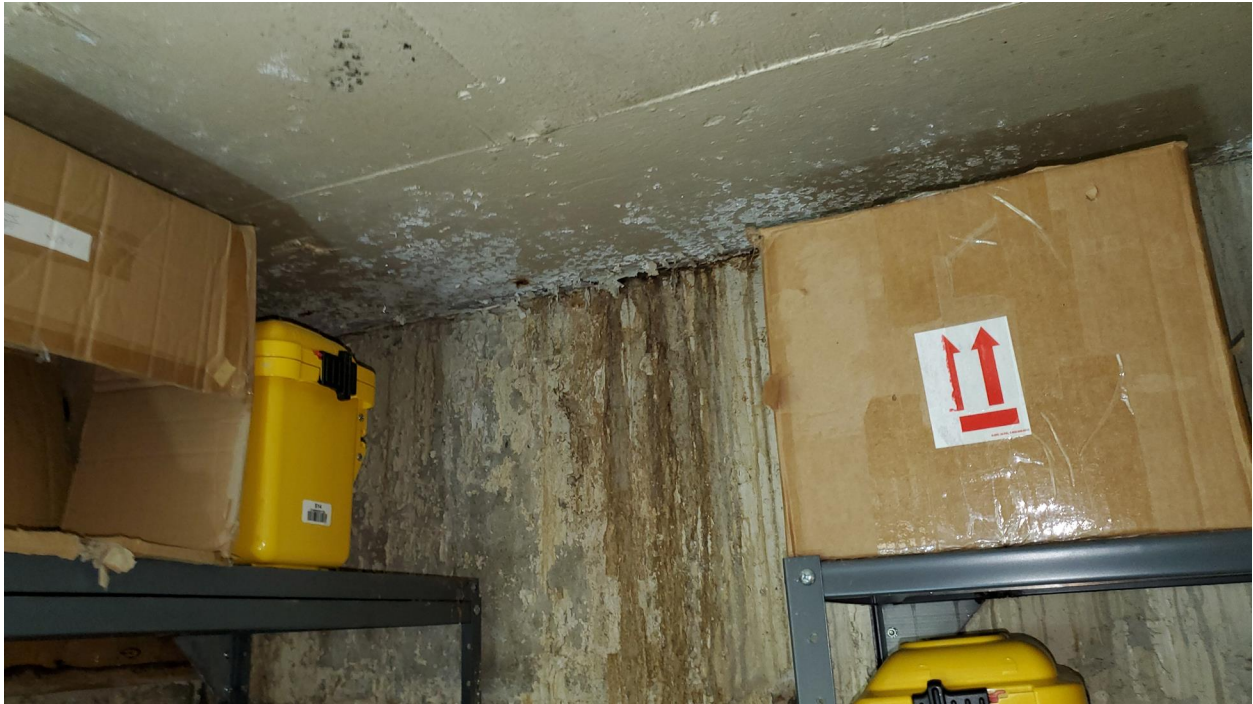
Figure 9: Cold-joint between the concrete slab and basement wall exhibiting evidence of excessive water infiltration.

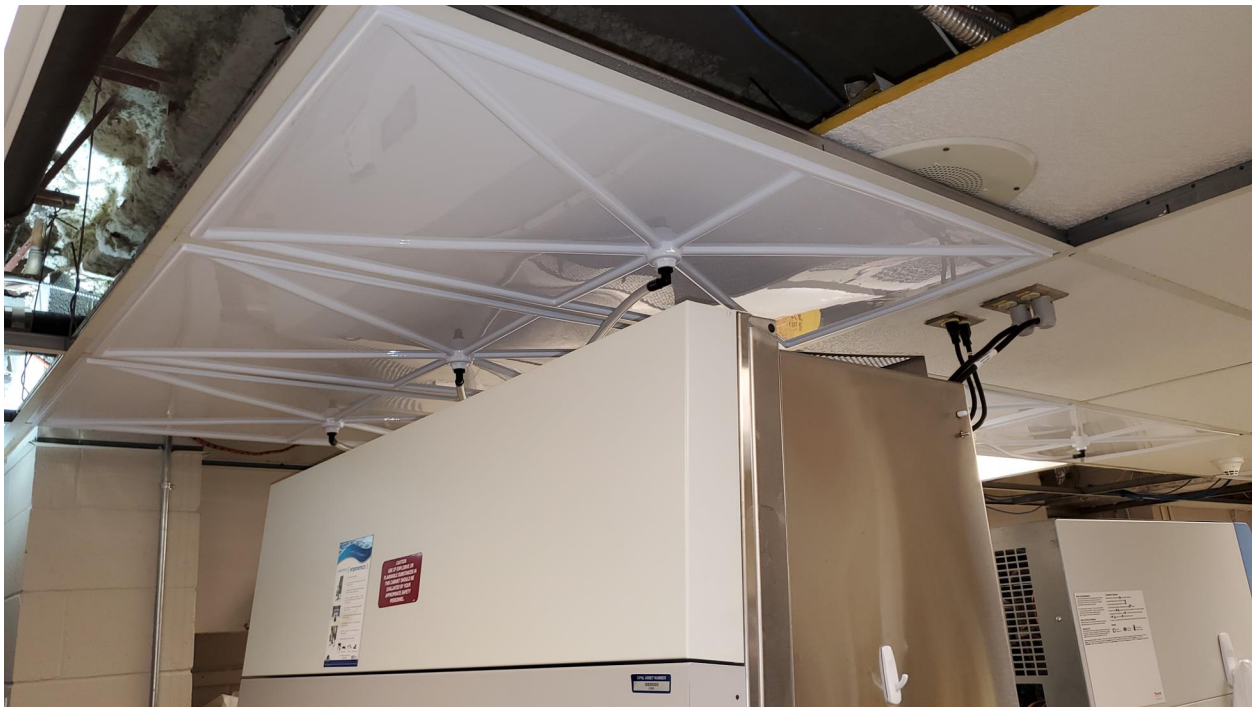
Figure 10: Ceiling catchment system installed in the Laboratory.

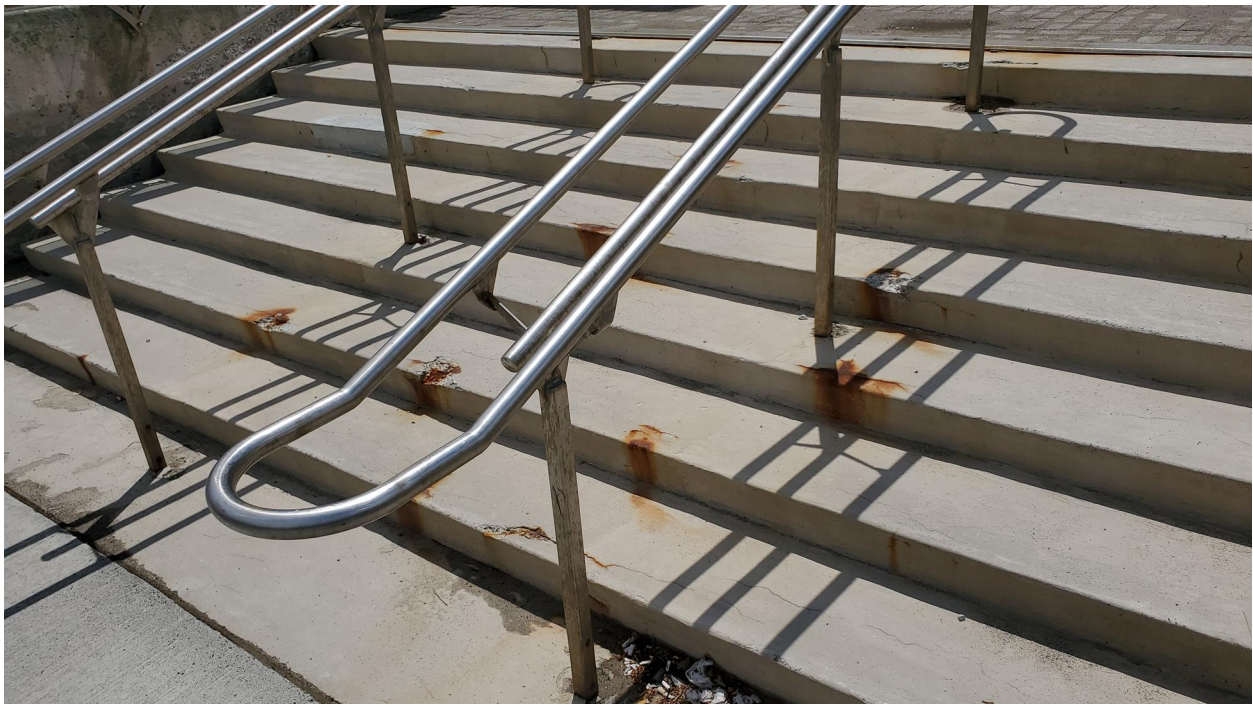
Figure 12: Lower stair. Note rust stains, cracks, and delaminated concrete.

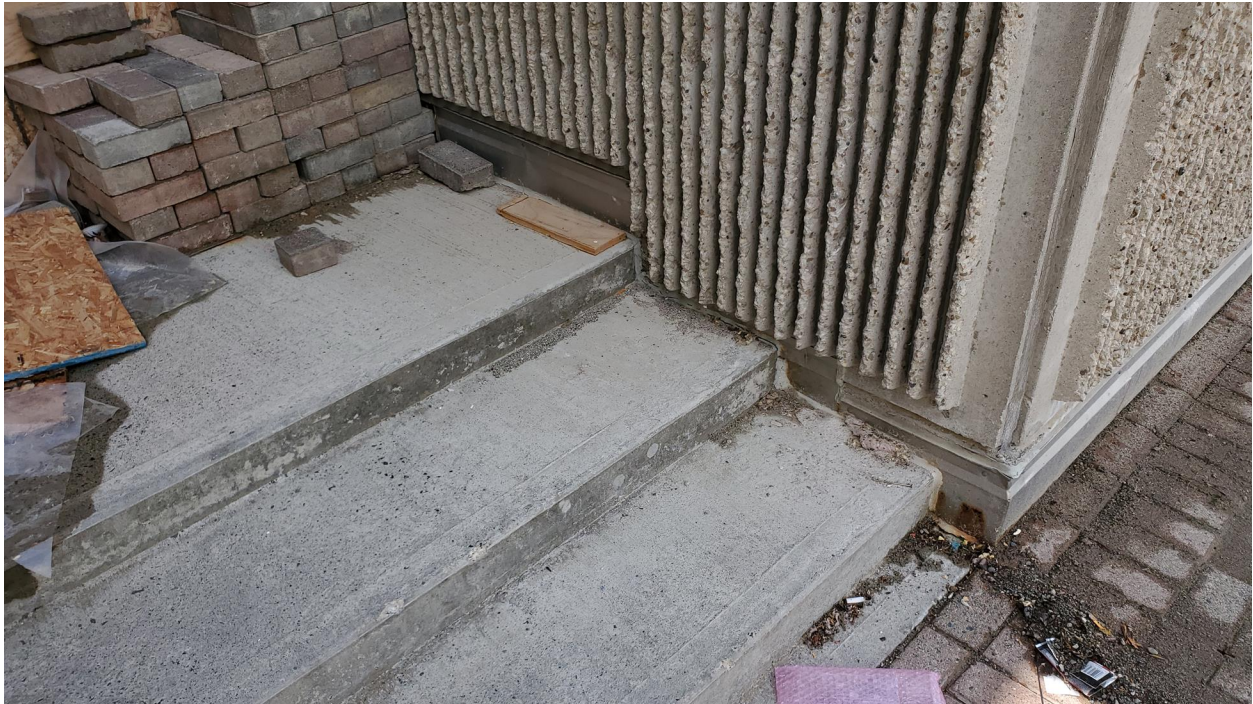
Figure 13: Upper stair.

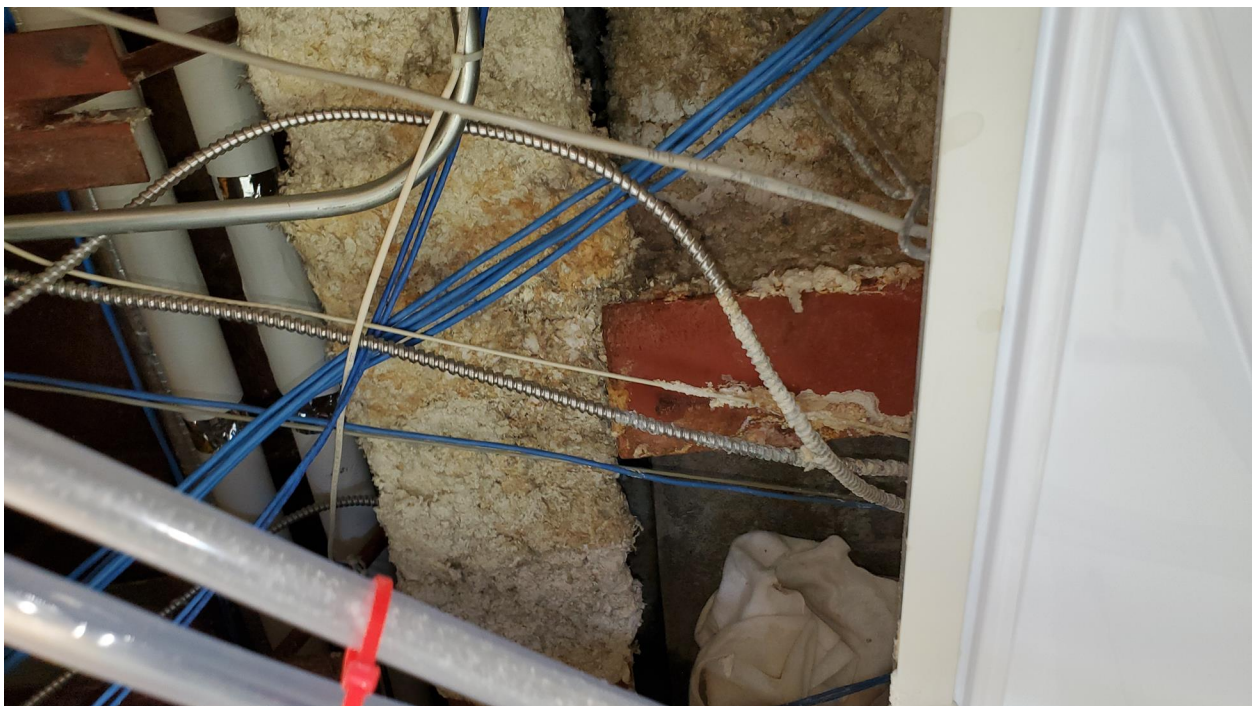
Figure 14: Spray-applied fireproofing on steel beam exhibiting minor exposure to water.

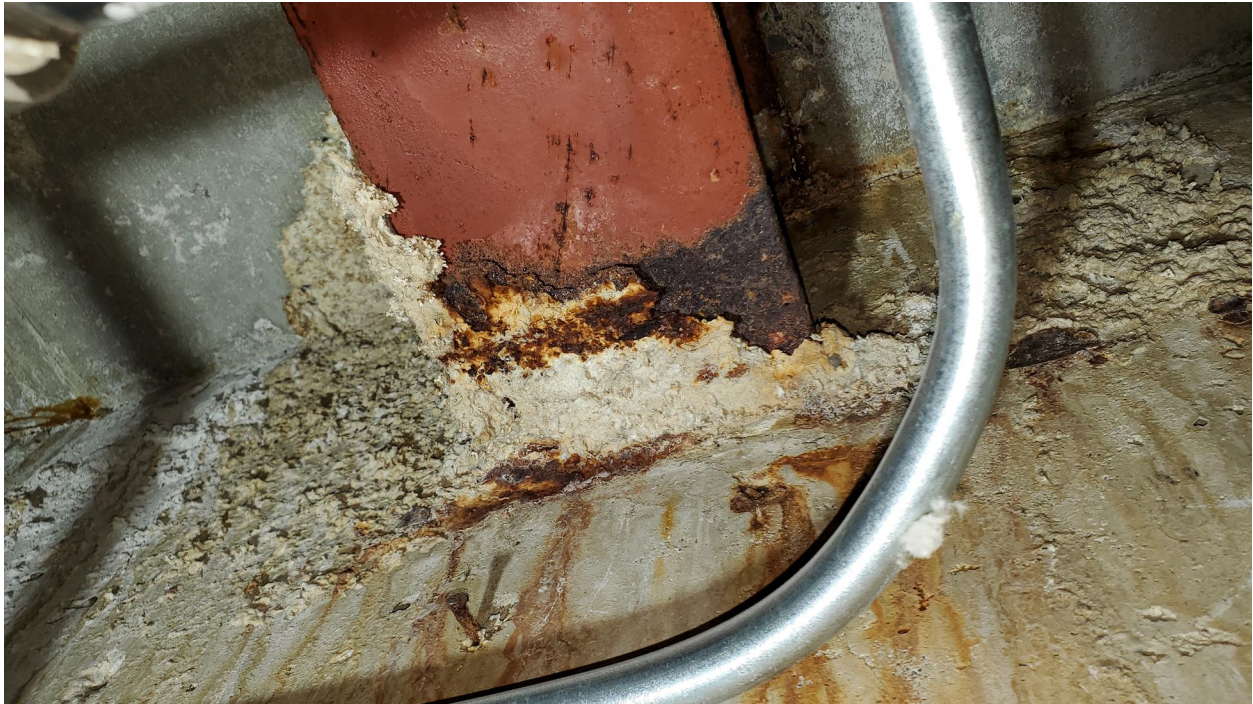
Figure 15: De-bonded spray-applied fireproofing and minor section loss of steel beam at basement wall.

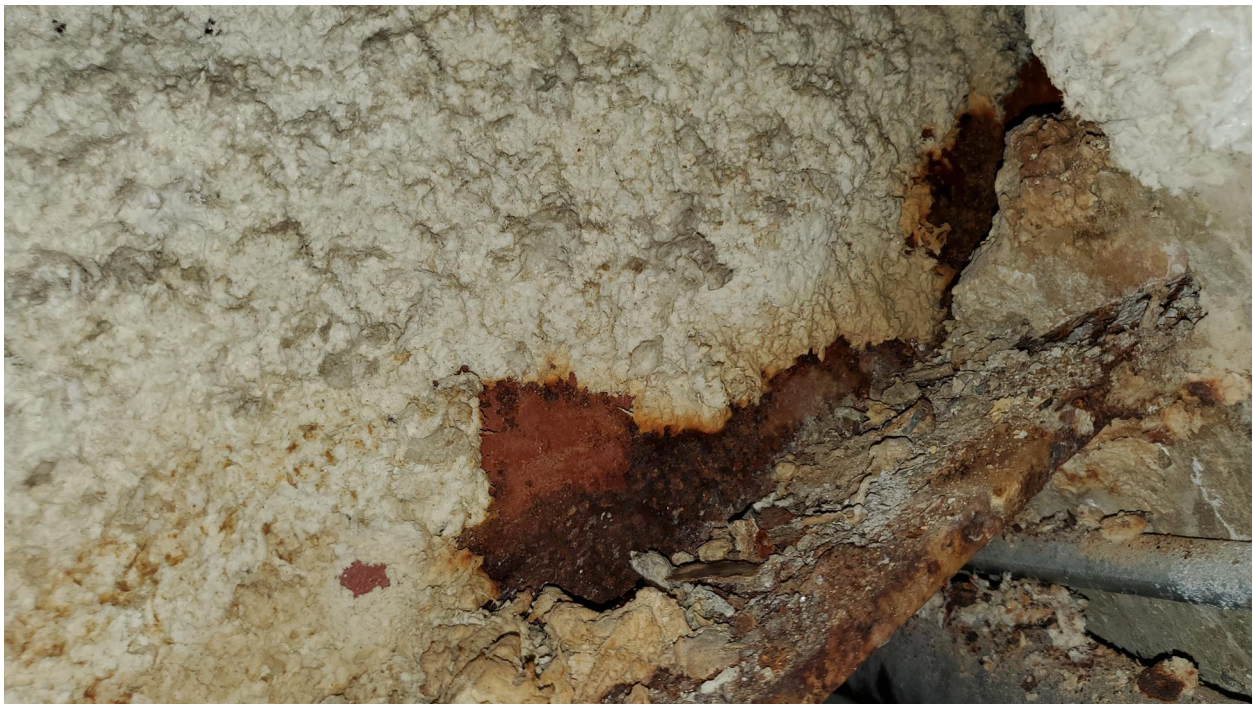
Figure 16: De-bonded spray-applied fireproofing and minor section loss of steel beam at basement wall.

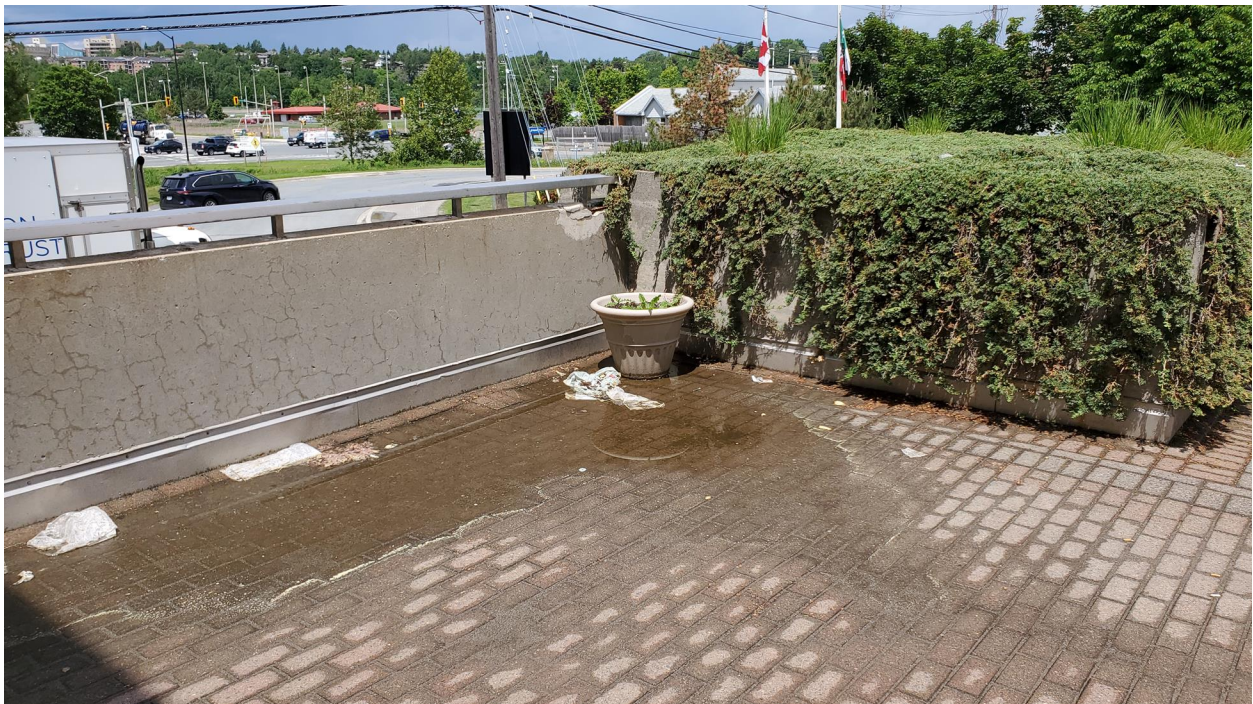
Figure 18: Standing water at west side of Podium.

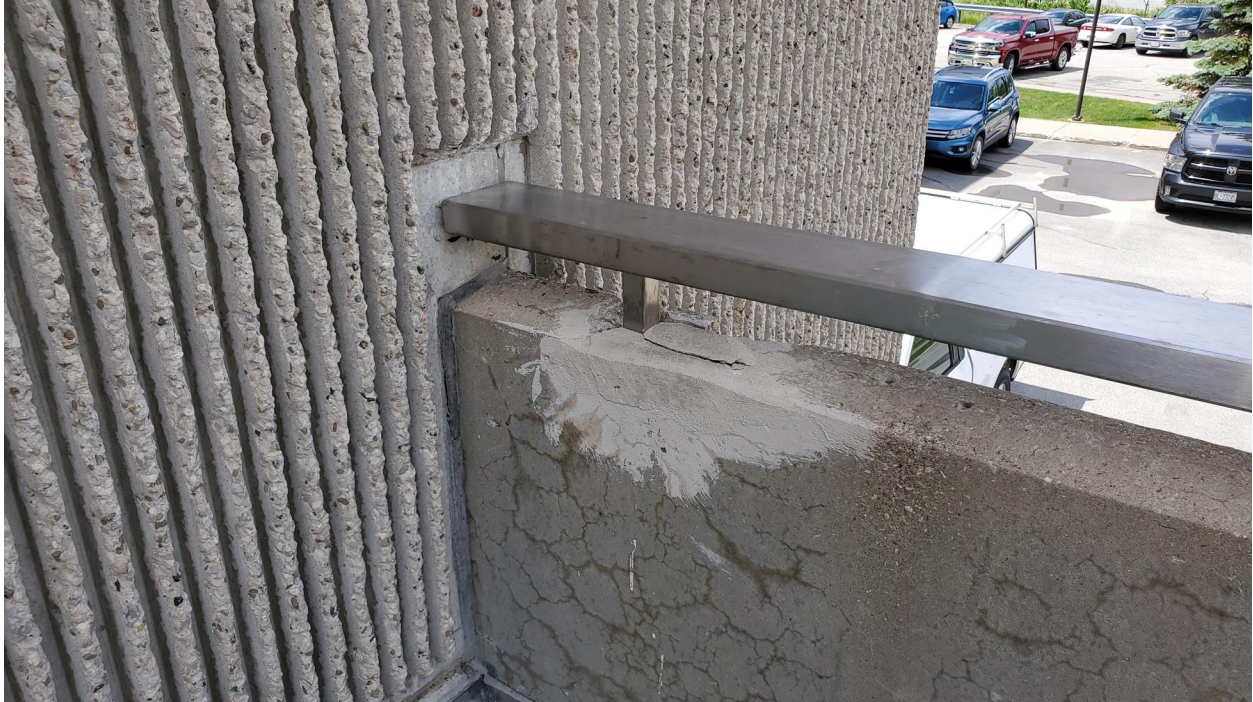
Figure 19: Map-cracking on concrete surface and previous repairs / delamination at steel guard connection.

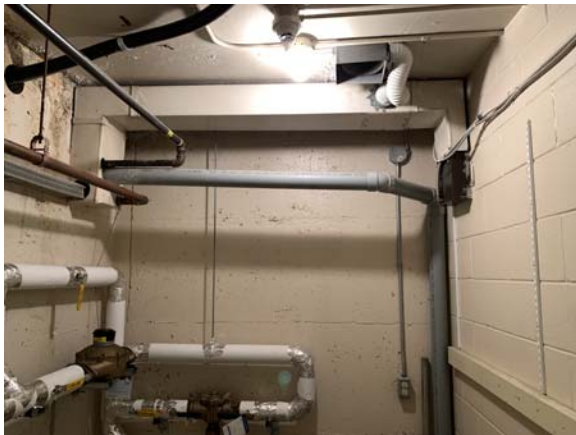
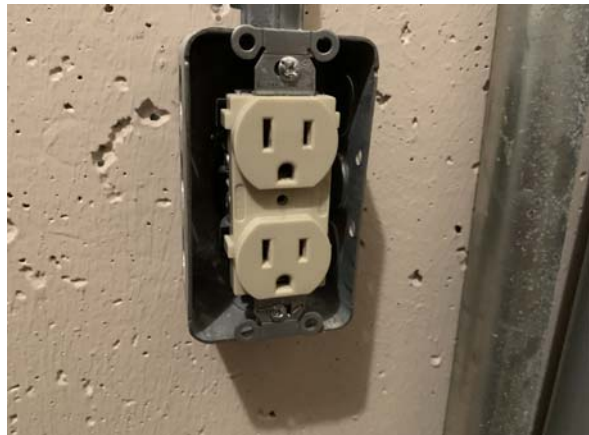
2.1.1 Water Room

- a) Significant rust and water damage visually observed on walls and ceiling, no damage or moisture observed in exterior wall mounted receptacle and back box.

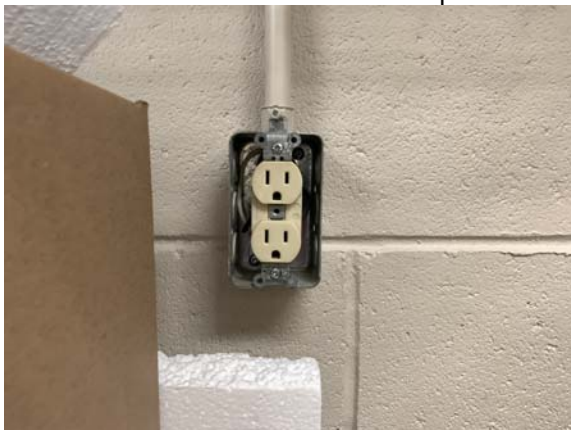
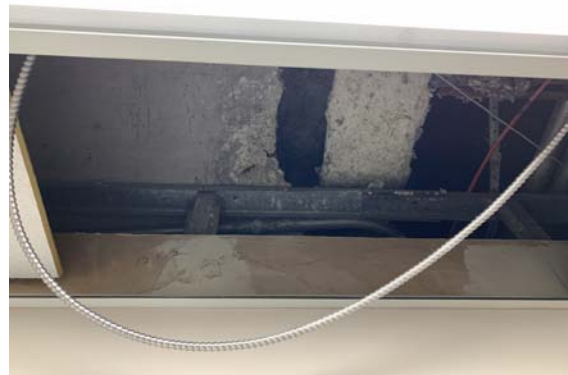
2.1.2 Lab Area

- a) Significant water damage visually observed on structure and ceiling tiles. No immediate dripping over electrical devices. No moisture observed within receptacle back box.

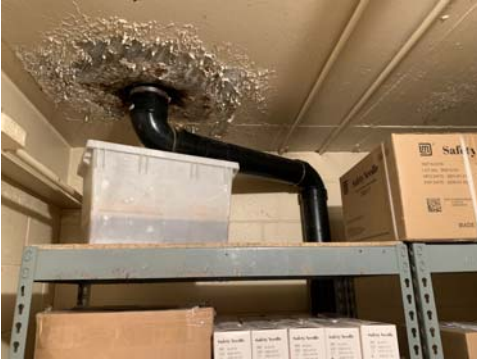
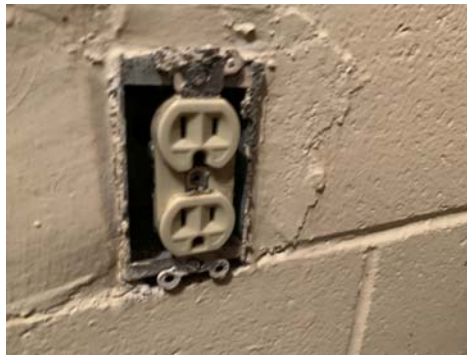
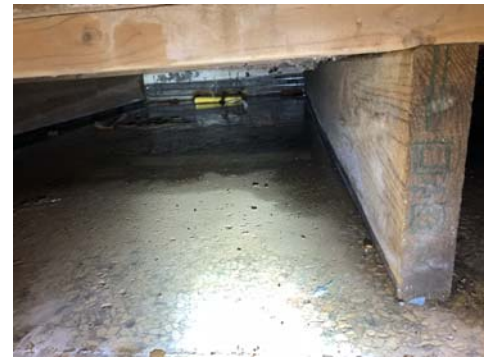
2.1.3 Storage Room

- a) Very significant water damage to ceiling located around existing drain from patio located above. No moisture observed within recessed mounted receptacle back box.
- b) Stagnant water observed beneath existing raised floor.

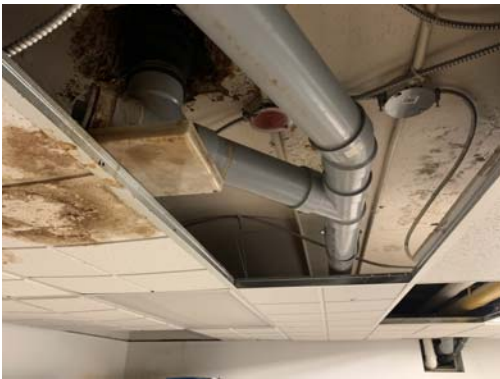
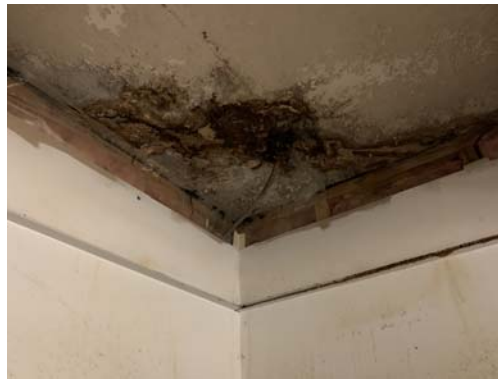
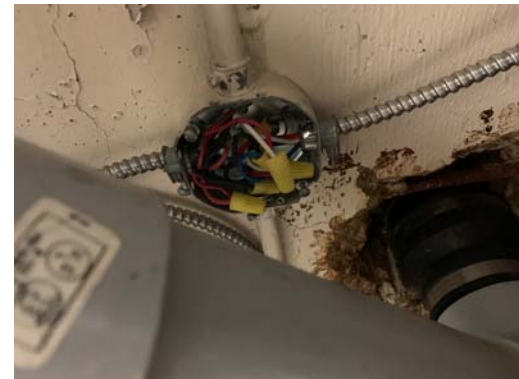
2.1.4 S/R Room

- a) Significant damage to ceiling tiles and exterior walls.
- b) Water damage appears to be originating from existing patio drain piping within ceiling space.
- c) Significant damage and rust on existing BX wiring running from roof slab into existing dry wall.
- d) No moisture observed within fire alarm system junction box.

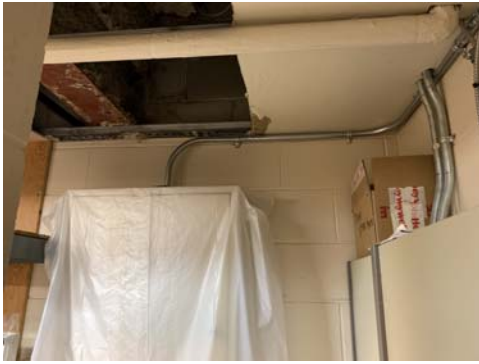
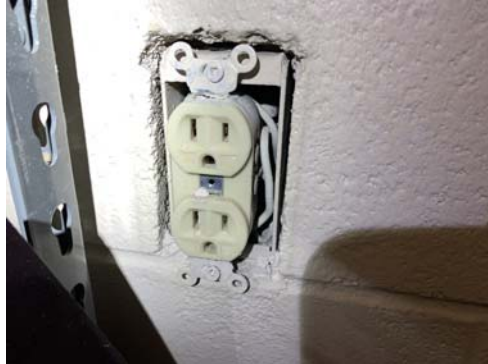
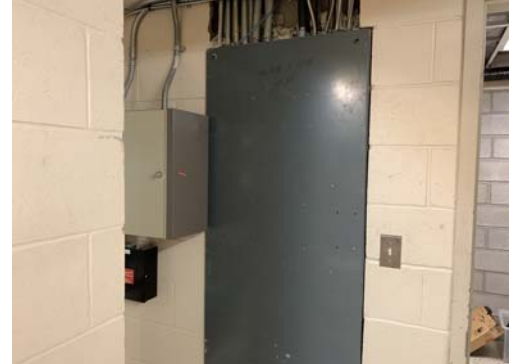
2.1.5 Telephone Room

- a) Water and moisture damage observed along structural beam in open ceiling space.
- b) No moisture damage observed in recessed receptacle back box.
- c) No moisture observed on back plate of electrical panel 'A' located in corridor.

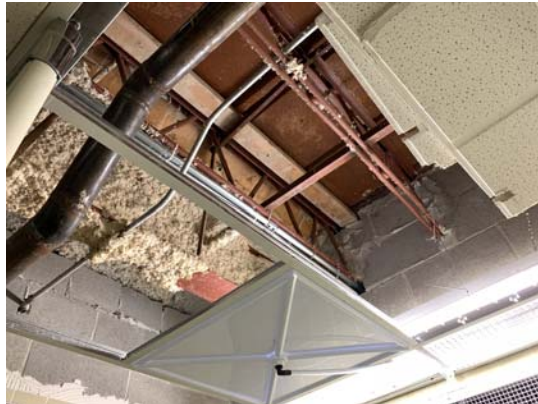
2.1.6 Women's Washroom

- a) Significant damage to underside of roof decking directly above existing lighting fixtures.
- b) No water observed to be draining onto fixture.
