Request for Proposal

**Terrace Repair at
1300 Paris Street**

Subject: PHSD Condition Assessment, 1300 Paris Street, Sudbury, ON

STRUCTURAL CONDITION ASSESSMENT

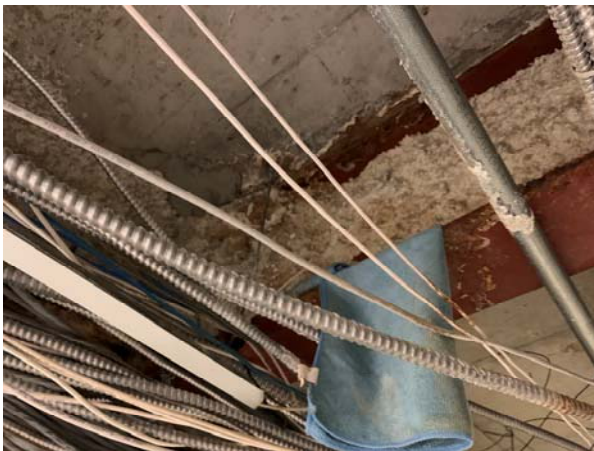
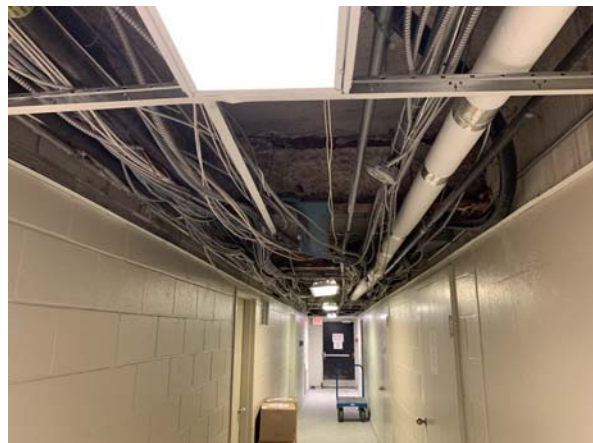
2.1.7 Corridor 102B

- a) Signs of consistent water damage along beam located directly above current carrying conductors and existing lighting fixtures.
- b) No dripping water observed.

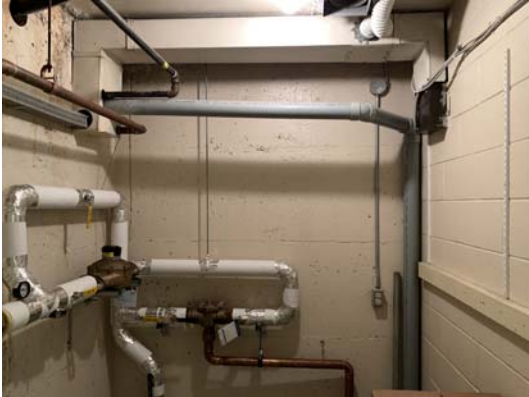
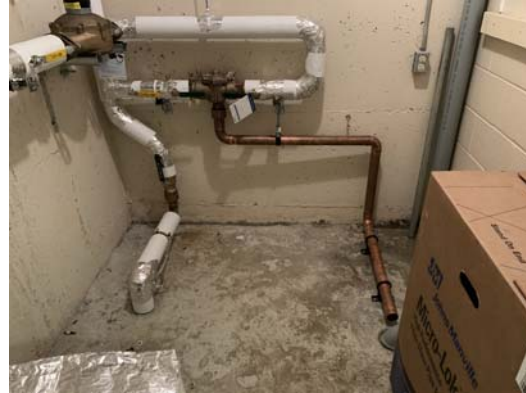
3.1.1 Water Room

- a) Water damage visually observed on walls and ceiling.
- b) No damage to mechanical equipment found, the plumbing services, water lines, and insulation have been upgraded recently.

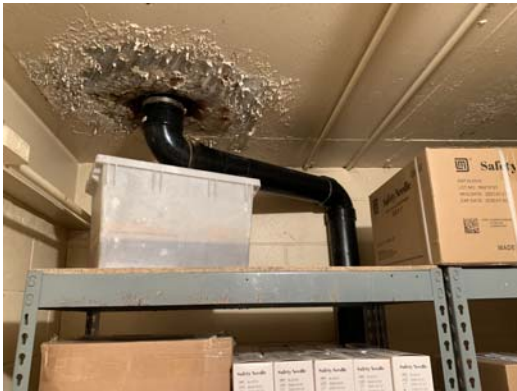
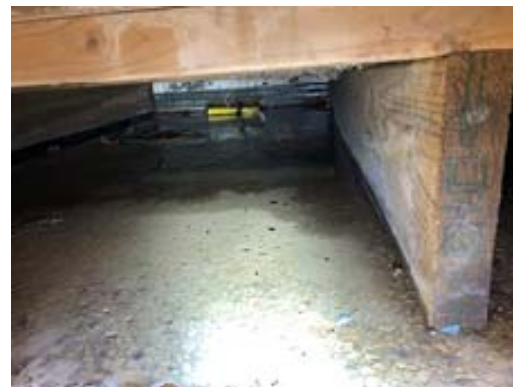
3.1.2 Storage Room

- a) Very significant water damage to ceiling and existing patio drain body.
- b) Significant amount of standing water observed on floor below wooden raised platform floor.
- c) Existing floor drainage system does not function correctly. (Based on existing drawings.)

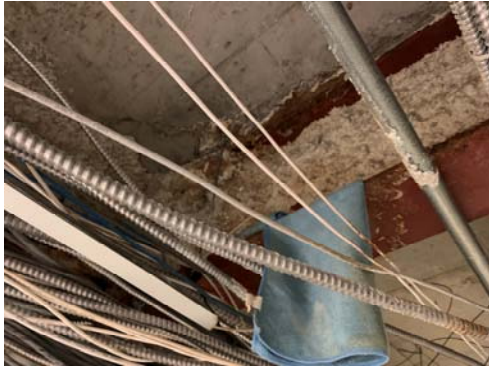
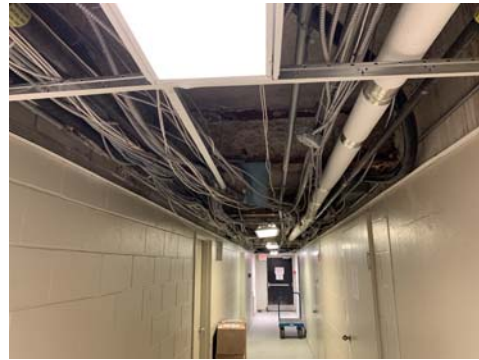
3.1.3 Corridor 102B

- a) Signs of consistent water damage along the steel beam.
- b) Mechanical systems such as insulated water lines do not show any signs of damage.

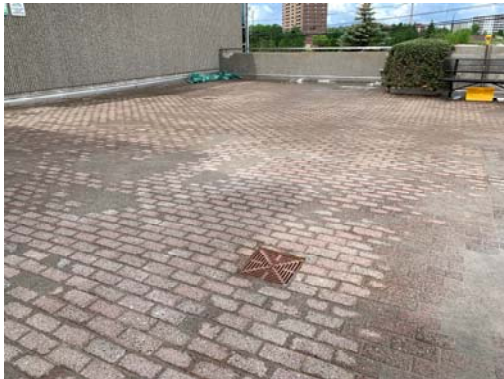
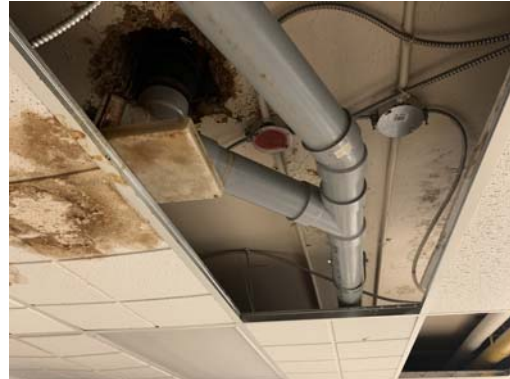
3.2 Patio Drainage System

- a) Existing patio drainage (3 drains) are cast bronze assembly with PVC and ABS piping distribution. (2 Lines)
- b) Both Lines are discharging fluid to the existing sanitary sewer drain system (located in water and storage rooms).
- c) Existing cast drain body nor piping is insulated.
- d) The patio storm liquid is discharging directly to sanitary sewer without any sand traps.
- e) Visible standing water in storage room maybe contributed to semi-plugged drain.
